Manhole Inspection Summary

Manhole # S69C__006MH

Insp Date: **5/21/08 12:33 PM**

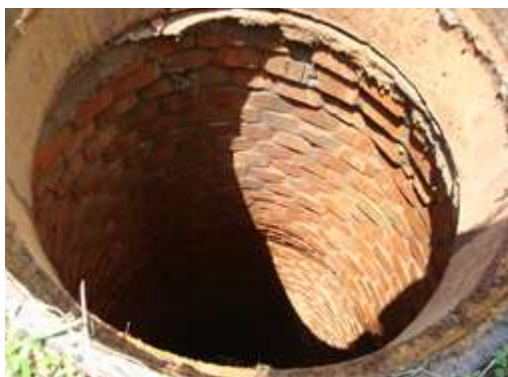
Defect 2

Frame Offset: **0** (in.) Condition: ☐ Sound ☐ Cracked ☒ **Leaks**

frame leaks

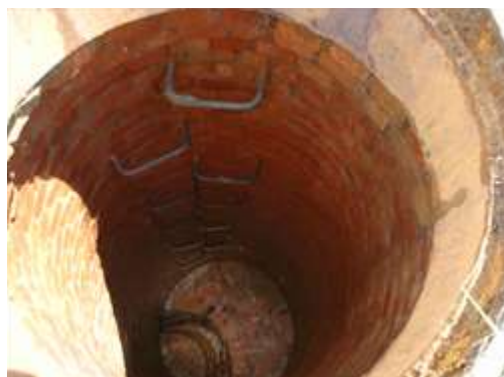
Defect 1

Infiltration: ☐ None ☒ **Joint** ☐ Cracks ☐ Mortar ☐ Roots ☐ Wall

Infiltration: ☐ None ☐ Joint ☐ Cracks ☐ Mortar ☐ Roots ☒ **Wall**

infiltration

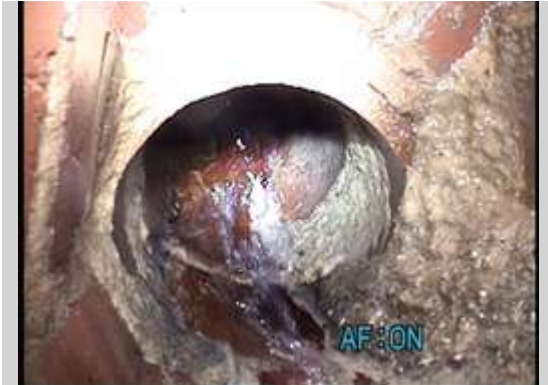
12 O'Clock Outflow

8 in. Circular Gravity Sewer
Pipe Out @ 12 O'Clock

Infiltration: **None** Pipe Seal Cond: **Sound**

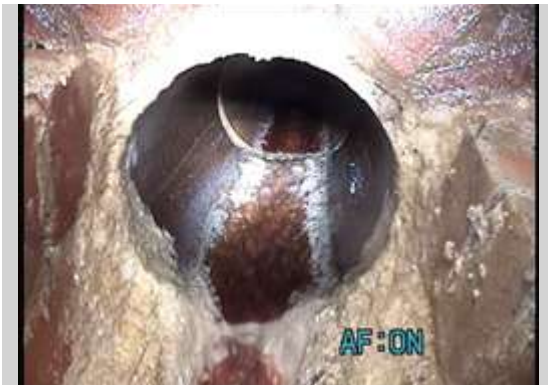
9 O'Clock Inflow

8 in. Circular Gravity Sewer
Pipe In @ 9 O'Clock

Infiltration: **None** Pipe Seal Cond: **Sound**
